Development of a Modern Sampling Device to Assess DDT Contamination on the Palos Verdes Shelf Superfund Site, California, USA

Chi-Li Tang, Chase McDonald, Terra Petry, Joseph Gully (Sanitation Districts of Los Angeles County, California, USA)

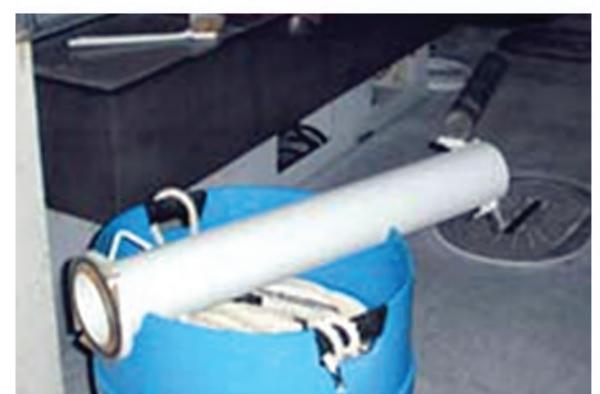
B) Empty barrel of the corer

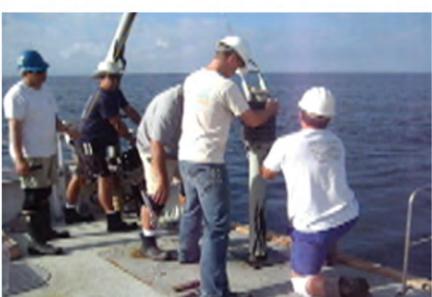
(E) Stabilizing the retrieved core on deck after sampling.

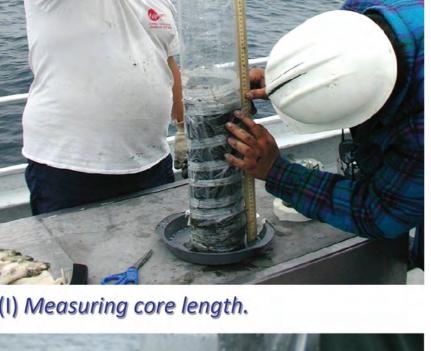
(I) Measuring core length.

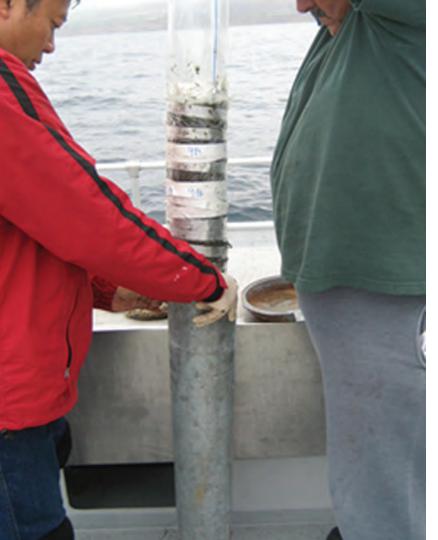
(K) Placing the core into a galvanized sleeve.

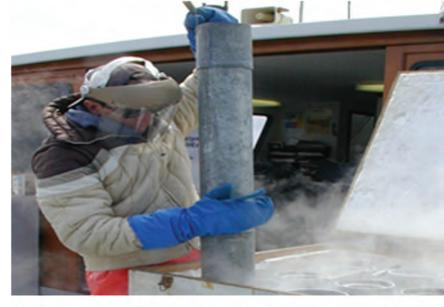
(M) Placing the core into a cold box with dry ice for preservation.

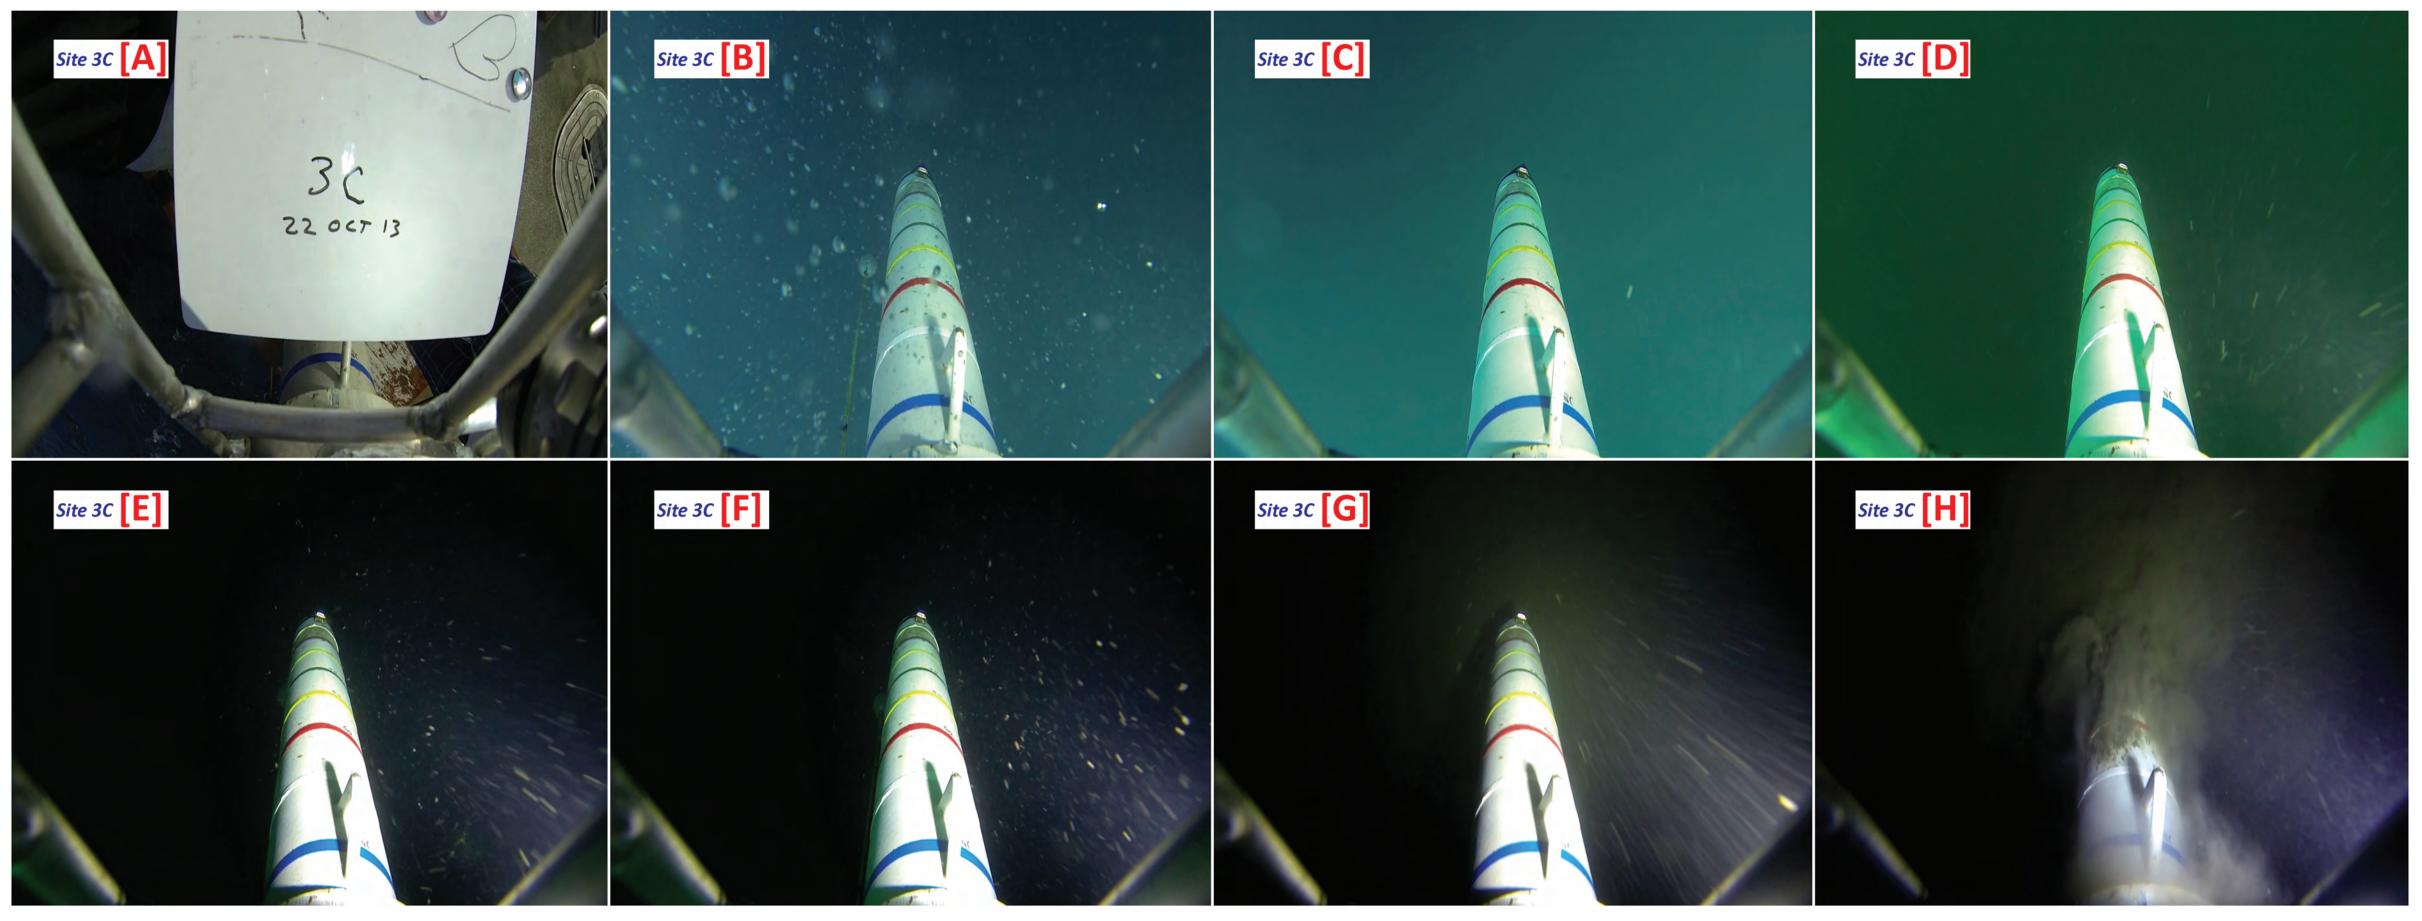
Figure 5 Screen captures for deep sediment coring conducted at station 3C on October 22, 2013

Screen captures from the video camera and tilt sensor results during a successful coring process at station 3C (60-meter water depth) on October 22, 2013, are illustrated in Figure 5 and Figure 6, respectively.

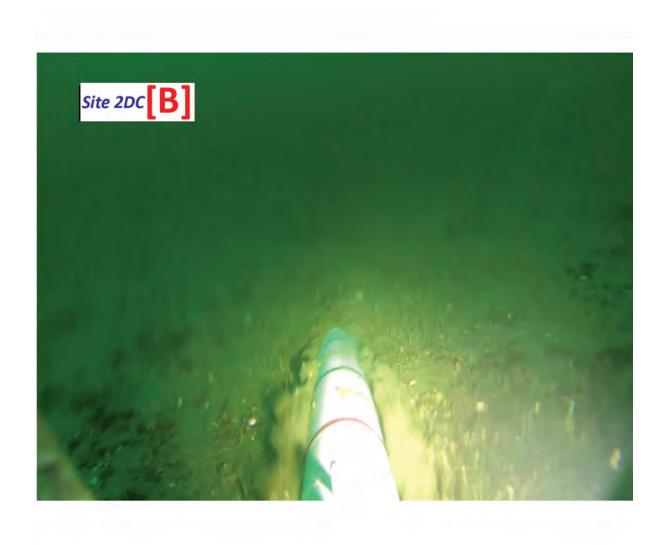
Figure 7 Deep Sediment Coring Conducted at Station 2DC on October 17, 2013. Core sampling event was rejected at station 2DC due to improper of angle penetration: the DST tag recorded 75 degree and 15 degree tilts on the X-axis and Z-axis respectively. These measurements were confirmed by the video footage of the slanted gravity corer (B).

Based on video footage, the camera brace appeared to add drag to the coring device, causing an angled entry into the sediments (Figure 7). The tilt sensor confirmed the video interpretations: 38% of the cores needed resampling when the video camera brace was attached, compared to 8% of the cores that needed resampling without the brace.
